# Navajo Abandoned Uranium Mine Site Screen Report

**C D & S AUM site**

**Navajo AUM Eastern Region**

**May 2009**

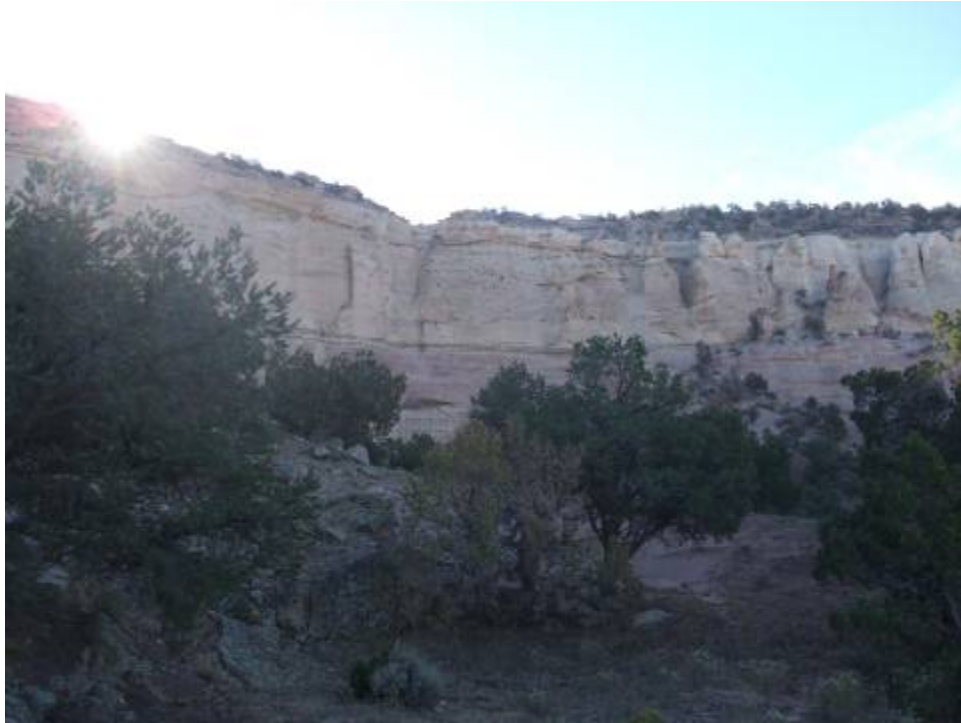
Reclamation status of the mine site is currently unknown. No visible signs of reclamation were observed. No waste piles, adits, or other mine features were observed during the site visit. The site was found alongside a large cliff-face, making much of the site inaccessible.

Photo 1. C D & S mine site, towards the south

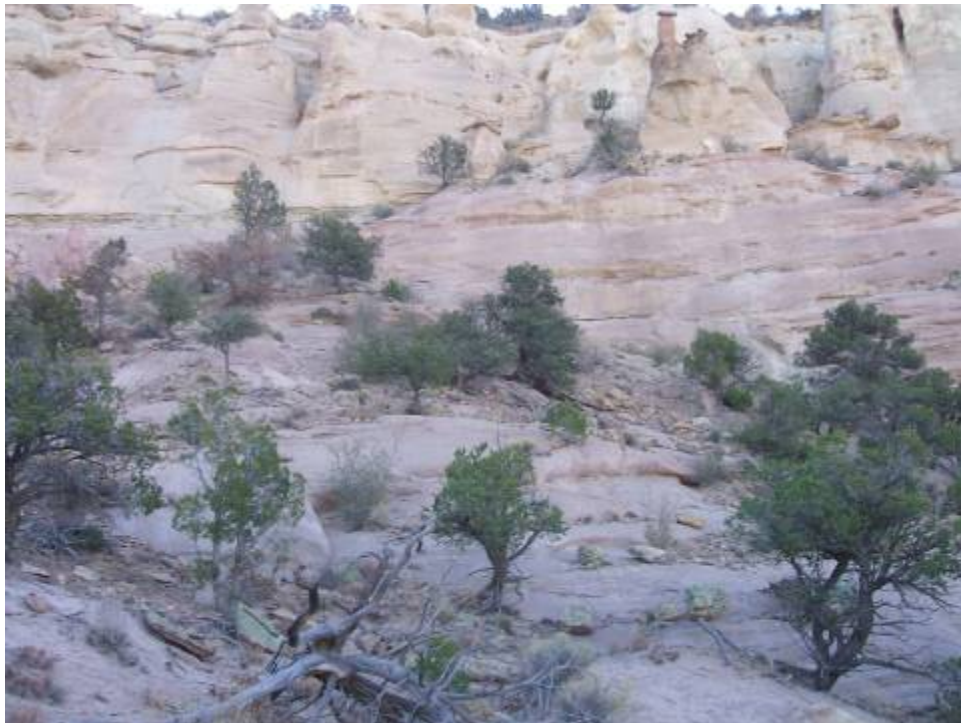
Photo 2. C D & S mine site, towards the east

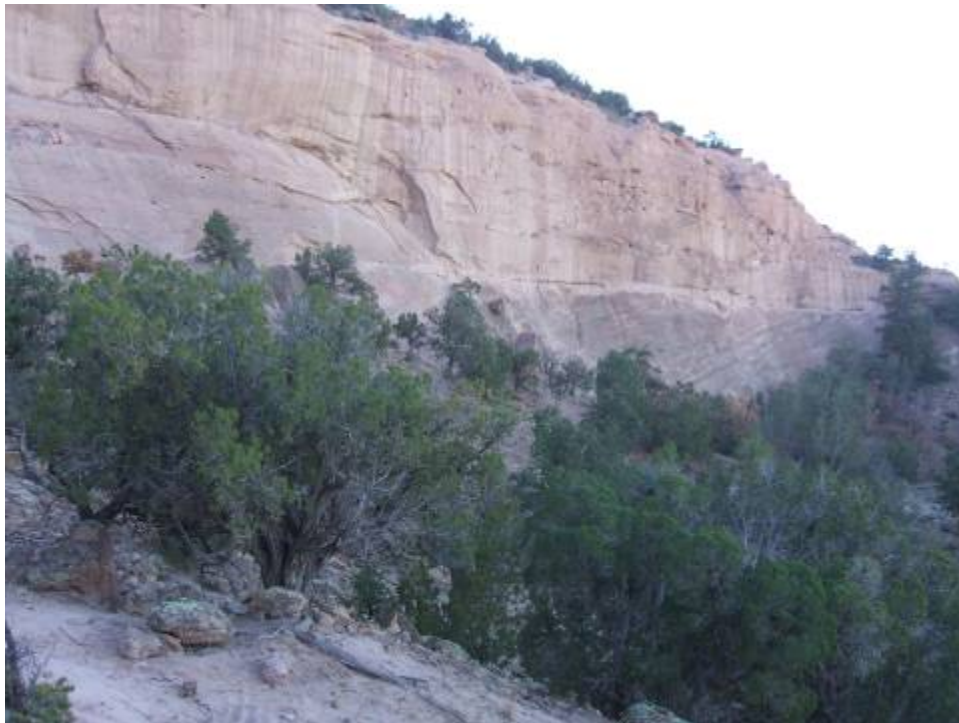
Photo 3. C D & S mine site, towards the southeast

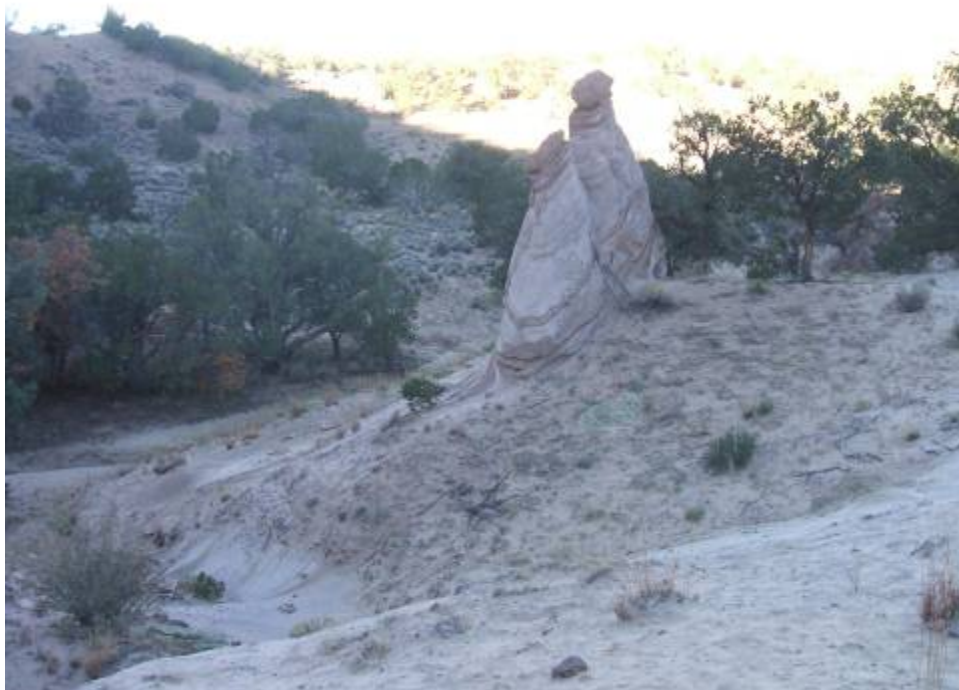
Photo 4. C D & S mine site, towards the southwest

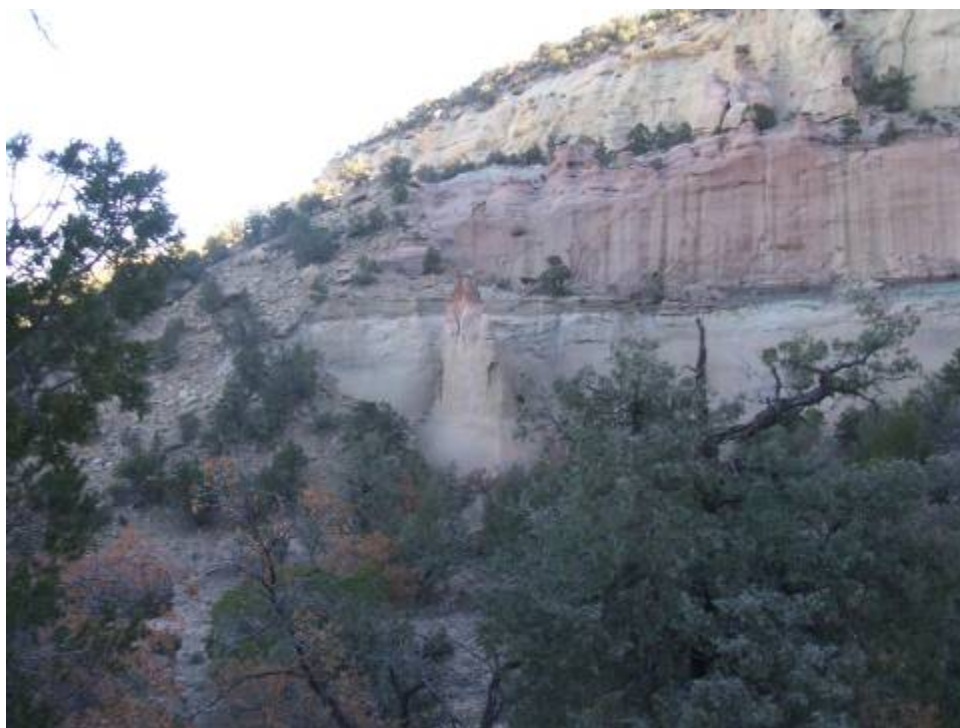
Photo 5. C D & S mine site, towards the northeast

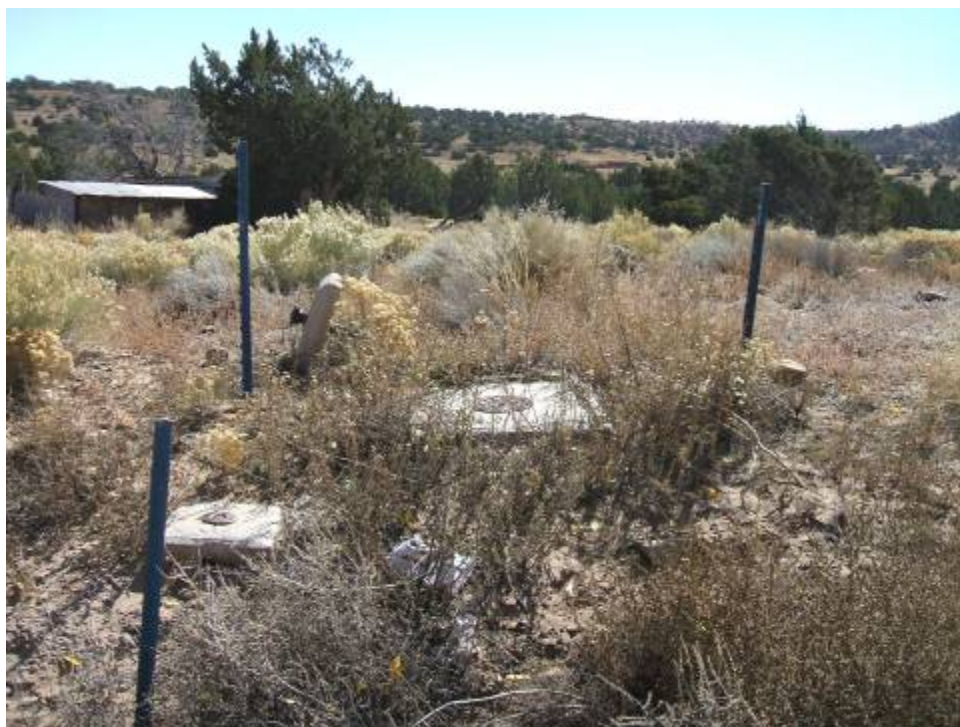
**0.25 miles to 4 miles:** 2 water wells were observed within the housing complex approximately 0.25 miles east of the site. Field personnel were unable to obtain any information regarding the usage or origin of the wells (Photo 6).

Photo 6. Wells approximately 0.25 miles southeast of mine site, towards the east

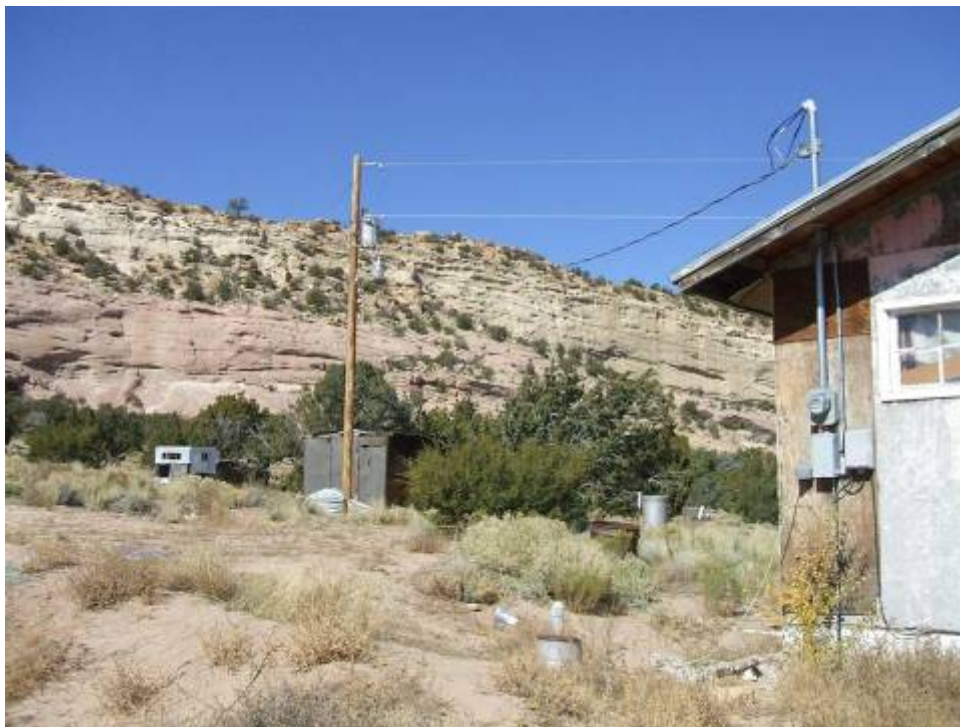
**200 feet to 0.25 mile:** 4 houses were observed approximately 0.25 miles east and southeast of the site, field personnel was unable to access the property to the east, and were unable to contact the residents to the southeast.

- 4 houses and 2 wells approximately 0.25 miles southeast of site – measured at 9,272 counts per minute (cpm).

Photo 7. Houses located approximately 0.25 miles southeast of mine site, towards the east

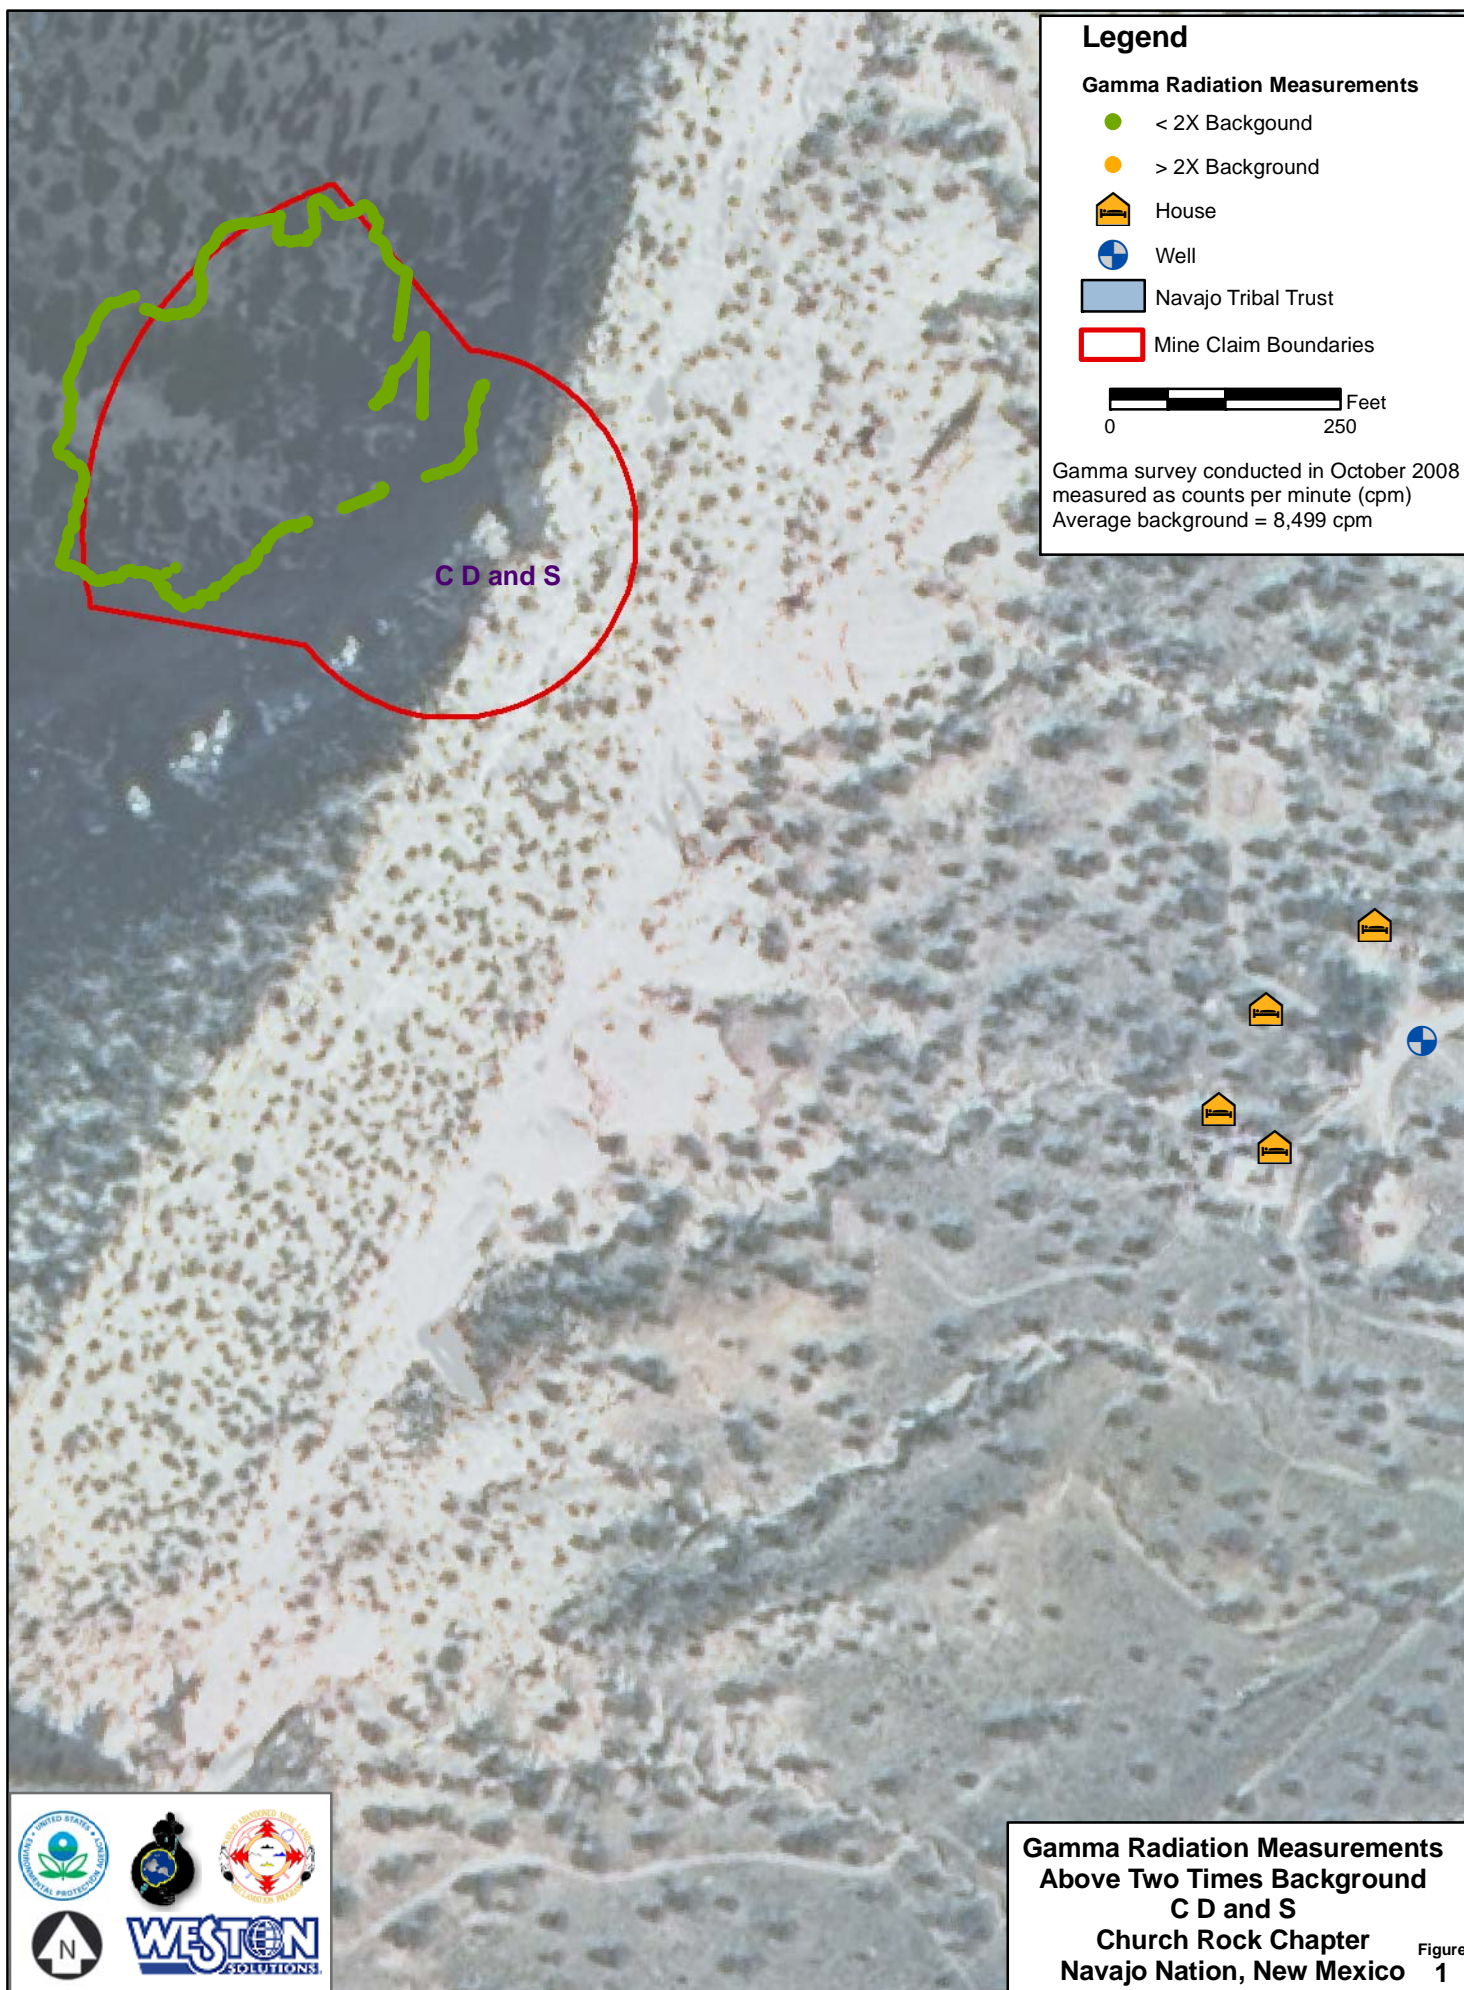
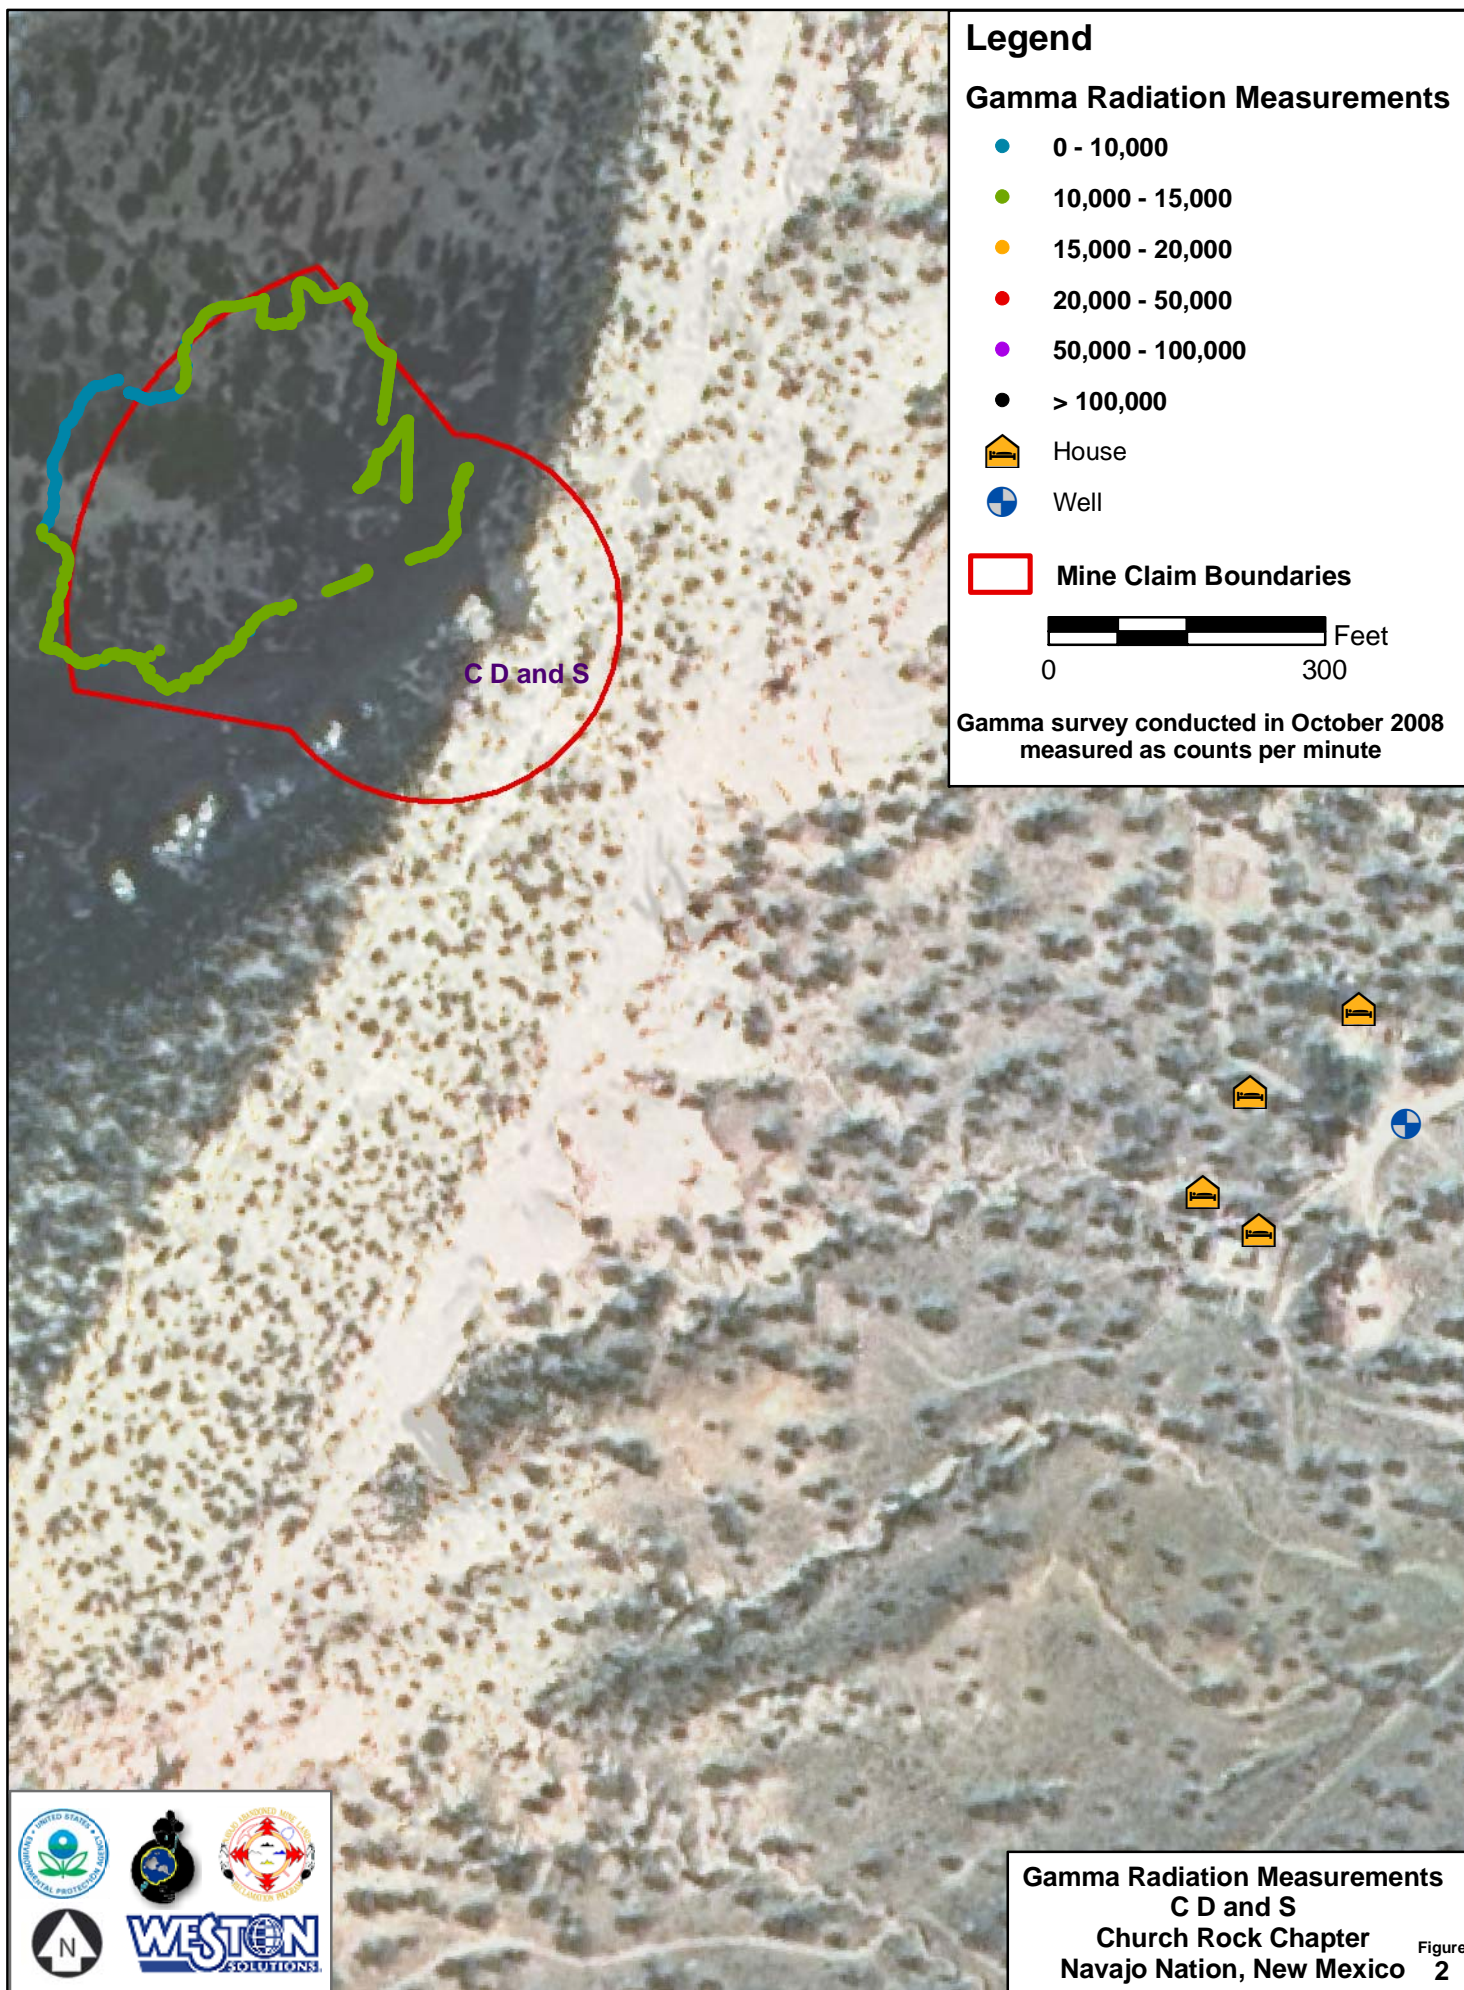
A total of 951 gamma radiation measurements were collected from mine sites, ranging from 7,198 cpm to 14,948 cpm. The measurements are represented in Figures 1 and 2.

5 residential houses and 2 water wells were located approximately 0.25 miles from the site. Gamma reading at the site did not exceed two-times background, and readings collected at the houses/wells were found to be consistent with the background levels.
